CLIENT:	Bliss Scaffolding	CONSULTANT:	Steve Trafford
SITE/DEPOT:	3 site visits	DATE OF VISIT:	18//12//2007
CONTACTS:	Keri Bliss - Dale Pinnock	REPORT TYPE:	Random Site and Scaffold inspections

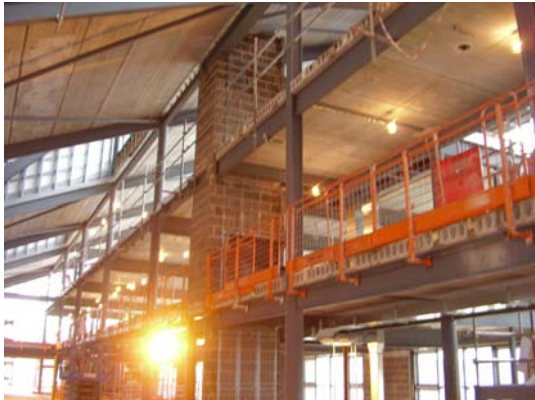
<p>Fig. 1 Floor edge protection</p> </div> <div style="text-align: center;">

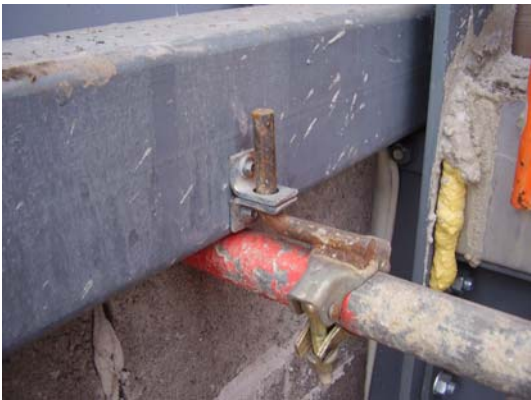
<p>Fig 2 Ties in position.</p> </div> </div> <p>The two end elevations featuring the curved scaffolding structures are part built with good ties in place. (Fig.2)</p> <p>The scaffold boards had all been cut on site and the overall fit was excellent. (Fig. 3)</p> <p>A section of edge protection required toe boarding, which was due for completion that day. (Fig.4)</p> <p>No problems were reported with interference</p> <p>The harnesses and lanyard seen were new issue and of a good standard.</p> <p>At time of visit all correct PPE was being worn.</p>
